AIRCRAFT ACCIDENT INVESTIGATION BUREAU

INVESTIGATION REPORT ON

ACCIDENT TO THE B737-MAX8 REG. ET-AVJ OPERATED

Report No. AI-01/19
Pub, Date December 23, 2022

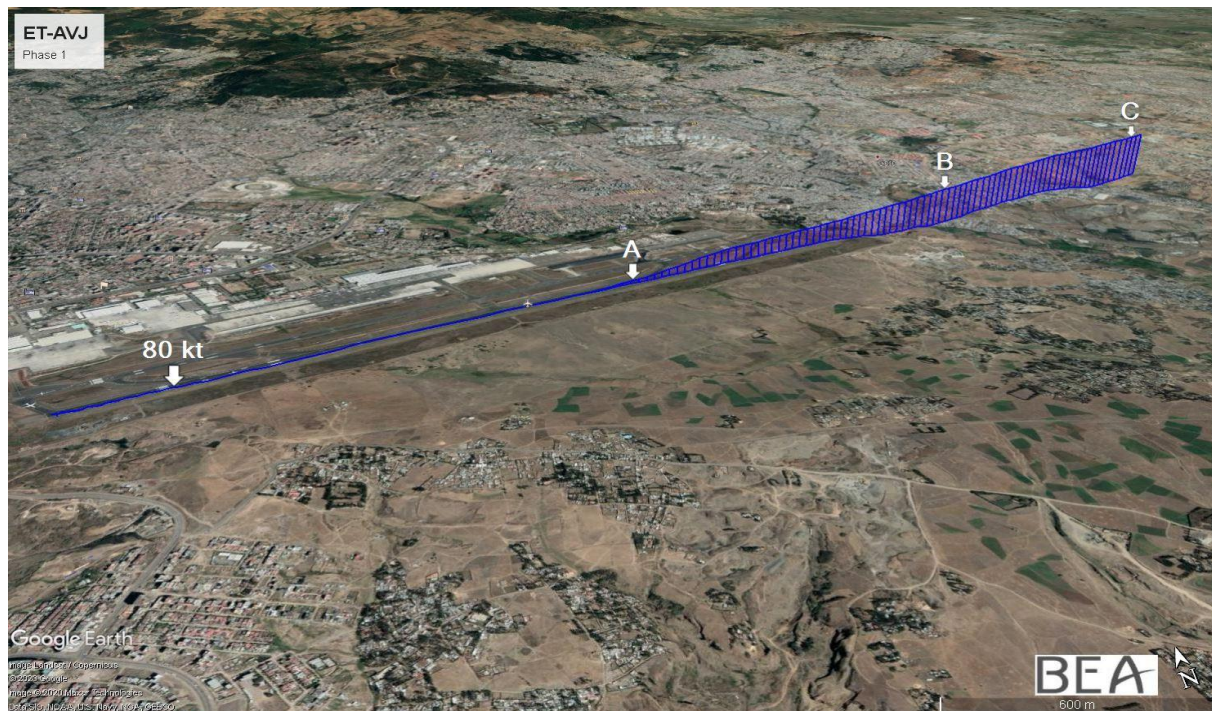
FIGURE 1: PHASE1 FROM TAKEOFF TO AUTOPILOT ENGAGEMENT

At 05:38:44, shortly after liftoff, the left and right recorded AOA values began deviating. Left AOA decreased to 11.1° then increased to 35.7° while value of right AOA indicated 14.94° (**point “A” in Figure 1**). Then after, the left AOA value reached 74.5° in $\frac{3}{4}$ seconds while the right AOA reached a Maximum value of 15.3° , the difference between the left and the right AOA values decreased from 59° to approximately 49° near the end of the recording, prior to the final dynamic behavior that was exhibited.

During the first phase of flight, the Airplane was kept in trim through the use of the crew-initiated main electric trim commands, there was limited force required on the control column.

Before CMD A engaged, the stabilizer trim position was around 5.6 units, with elevator positions around 4° (consistent with the elevator neutral position for the stabilized flight condition).

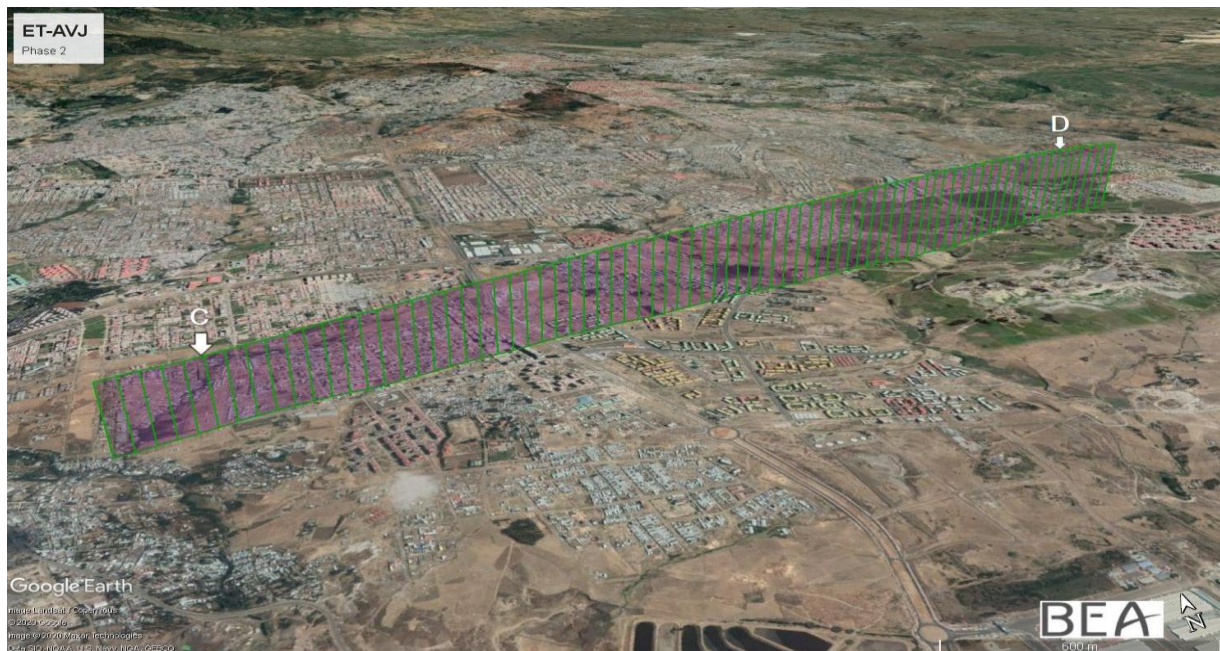
FIGURE 2: PHASE 2 DURING AUTOPILOT CONTROL

At 05:39:56, the A/P disconnected automatically (**point D**) after remaining engaged for 32 seconds as the following logic conditions were reached:

The engagement of the LVL CHG mode and the new associated target speed most probably led to several transient AP mode computations leading to the decrease in vertical speed to stop at around 450 ft/min and the pitch values to stabilize at around 4°. After that, the erroneous excessive minimum speed related to the erroneous AOA triggered again an AP pitch down command to increase the speed. After reaching a Maximum altitude of around 9,100 ft (RH baro corrected altitude) during this phase, the Airplane started descending, triggering the autopilot to disconnect.

At the end of this phase, the pitch angle was around 1°, the stabilizer was at 4.6 units and the vertical speed was around -1,400 ft/min. Flaps were still moving up.

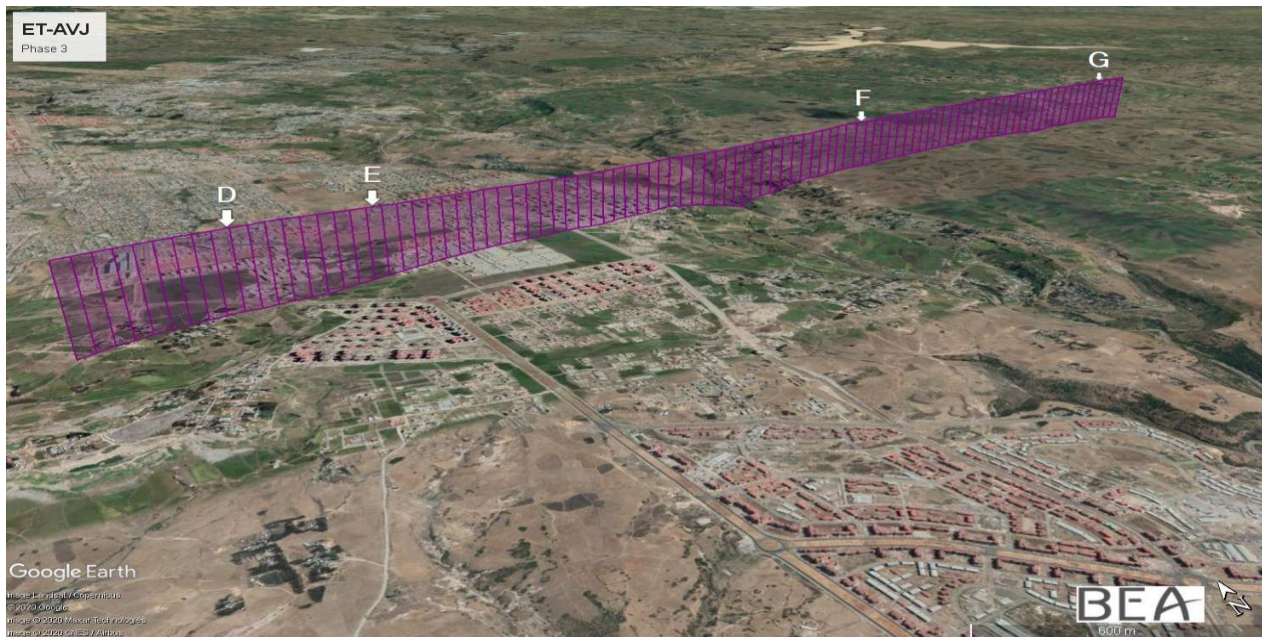
FIGURE3: PHASE 3 FROM A/P DISCONNECT TO STABILIZER TRIM CUTOUT

The F/O then twice suggested "stab trim cut out?" The Captain replied "yes yes do it". The stab trim cut-out switches were most likely put in the cut-out position at about 5 h 40 min 38 s **(point G Figure 3)**. At this time:

At the beginning, FMC detected a significant difference between the RH and LH True Airspeed (erroneous LH ADIRU computed values due to erroneous LH AOA value). From this time, FMC did not send any valid command to A/T. The A/T stayed in the Arm Mode. The loss of valid FMC command did not trigger an explicit alert but did result in the FMA continuing to display "ARM" instead of changing to "N1" as would normally be expected.

As a result of the erroneous LH AOA value and the increasing airspeed, SMYDC 1 computed LH minimum operational speed and LH stick shaker speed greater than VMO (340Kt) without any alert or invalidity detection.

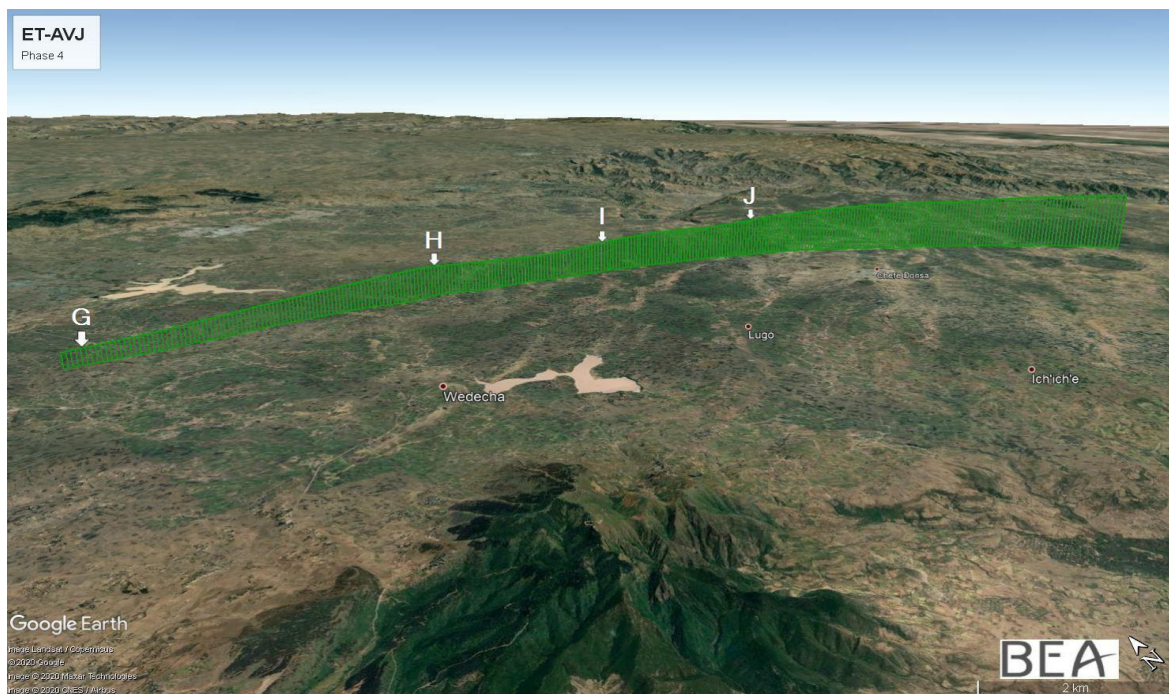
FIGURE 4: PHASE 4 FLIGHT WHILE THE STAB TRIM CUTOUT SWITCHES WERE IN THE CUTOUT POSITION

At 05:41:47, the Captain asked the F/O if the trim was functional. The First-Officer replied that the trim was not working and asked if he could try it manually. The Captain told him to try **(Point I Figure 4)**.

- The Airplane was at an altitude of 6,200 ft above the airfield elevation (computed from the RH pressure altitude). LH altitude values were 1,250 ft lower.
- Computed airspeed was around 367Kt (RH value), LH erroneous value was 344 Kt.
- The pitch angle of the Airplane was lower than 1°
- The vertical speed was around + 125 ft/min and decreasing
- The bank angle was around 21° right, with a slight trend to increase.

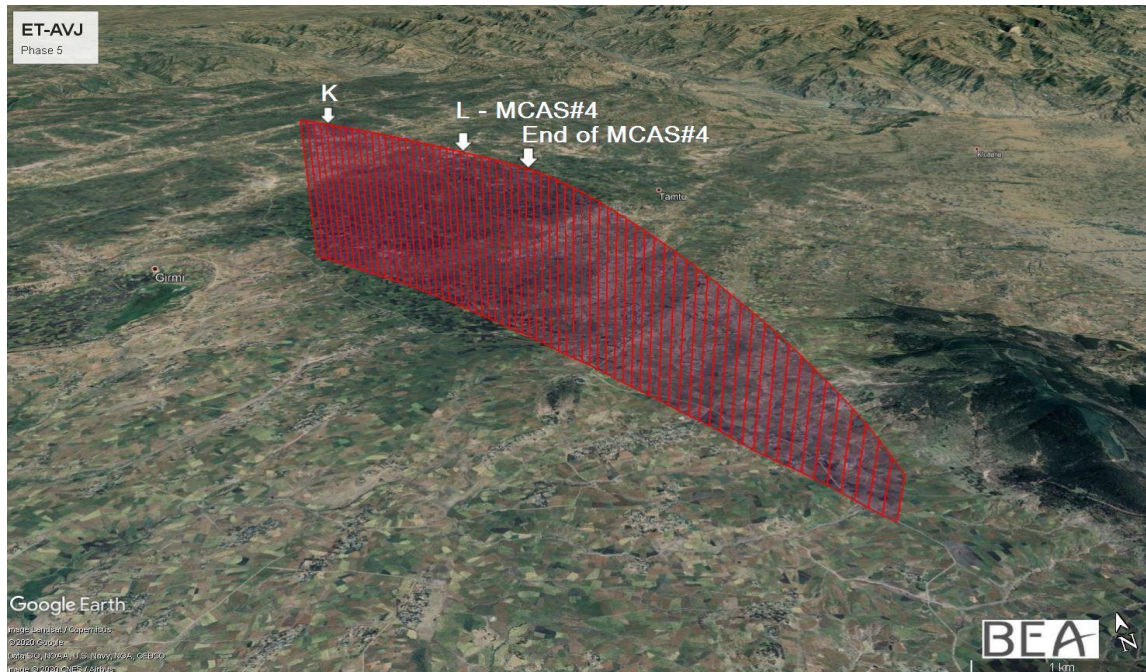
FIGURE 5: PHASE 5 STAB TRIM CUT OUT SWITCHES BACK IN NORMAL POSITION

Both recorders stopped recording at around 05 h 43 min 44 s.

⁹The FDR discrete parameter of the manual electric trim command records command (up or down) only when both stab trim cutout switches are in the normal position

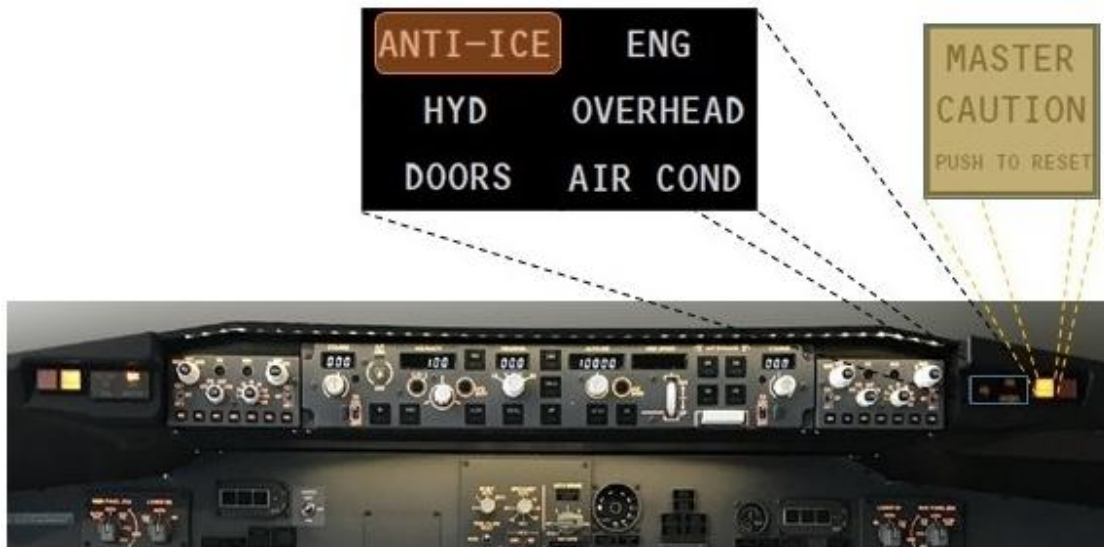
FIGURE9: MASTER CAUTION ANTI-ICE

- the master caution triggers (master caution light illuminates)
- the ANTI-ICE light (right system annunciator) illuminates
- The [L/R] ALPHA VANE message illuminates (on the Probe heat panel of overhead panel).

The vane heating monitoring is based on current detection circuit. After the current drops, there is a delay of 3 to 5 s before the light “[L/R] Alpha Vane” illuminates and the master caution triggers. In other words, the airplane suffered a loss of power to the left AOA Sensor Heater.

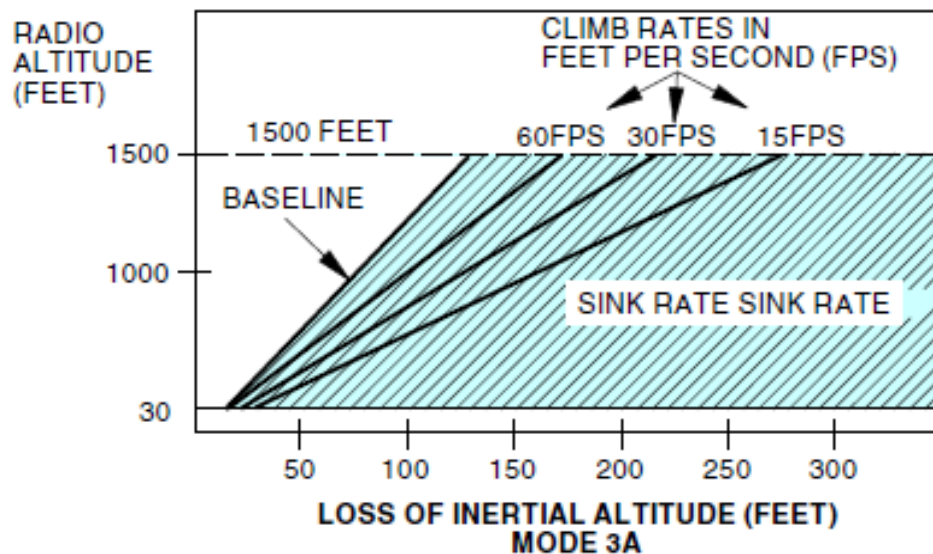
FIGURE26: ALERT ENVELOPE FOR THE MODE 3A (FROM AMM §34-49-00)

The mean vertical speed of the Airplane before the Maximum value was around 12 ft/s. An alert triggering around 1,271 ft – after 229 ft of altitude loss was consistent with the GPWS Mode 3A alert envelop shown in Figure 26.

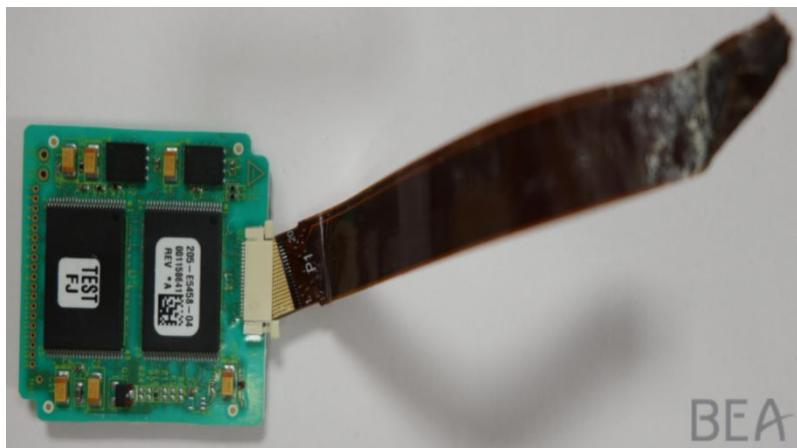
FIGURE 39: CVR MEMORY BOARD AND FLEX

The CVR memory board and flex were visually inspected with the Keyence microscope. There was no damage on the board and the connector was in good condition.

A second observation with the X-ray was made, which confirmed that the connector soldering were in good condition.

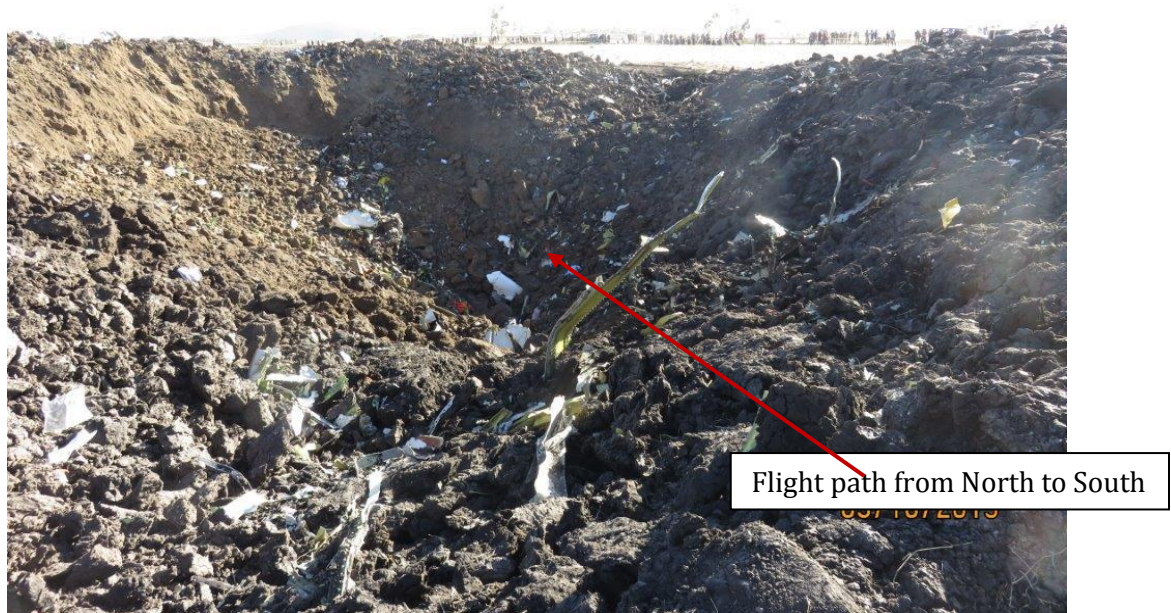
FIGURE 41: CLOSE VIEW OF THE CRATER BEFORE EXCAVATION

The Airplane impacted terrain at a farm field and created a crater approximately 10 meters deep (last Airplane part found) with a hole of about 28 meters width and 40 meters length. Most of the wreckage was found buried in the ground; small fragments of the Airplane were found scattered around the site in an area about 200 meters wide and 300 meters long. Damages to the Airplane were consistent with a high energy impact.

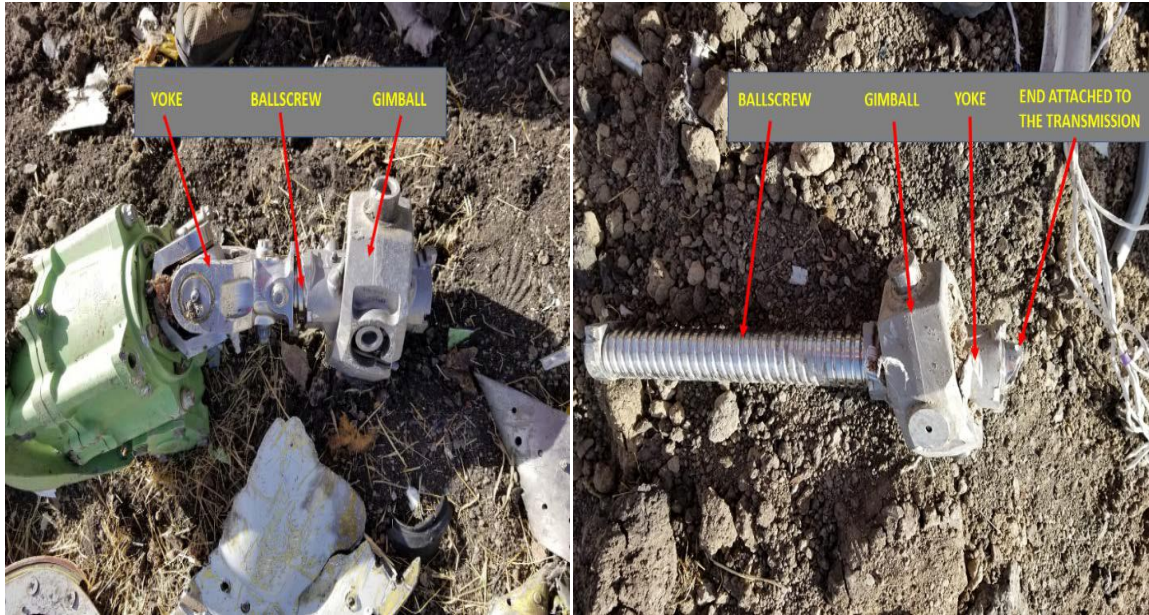
FIGURE54: FLAP TRANSMISSION & BALLSCREW FIGURE55: FLAP TRANSMISSION

The installed location of each unit has not been identified. The position of each gimbal is consistent with the flaps in the fully retracted position.

Again, all three were found in the fully retracted position. There was one additional transmission portion that was found as well as three ball screw segments. All examined damage appears consistent with high energy impact.

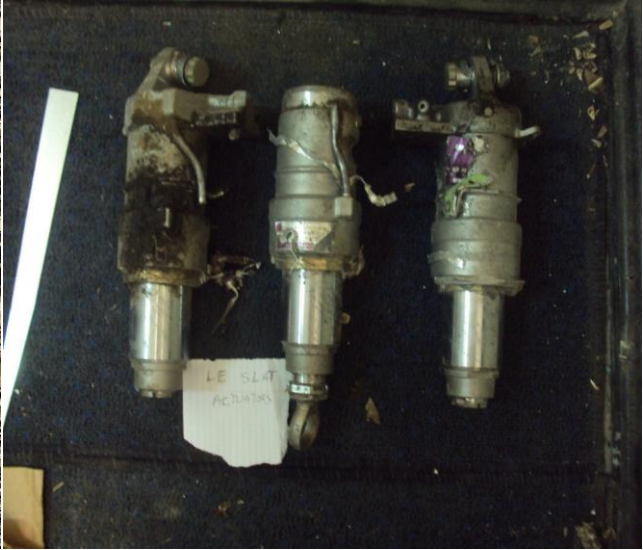
FIGURE 58: LEADING EDGE SLAT ACTUATORS

During the examination of the wreckage pile located at the Addis Ababa airport EAIB store the Airworthiness group identified a total of three leading edge slat actuators at the impact site. The actuator position, as photographed, was in the fully retracted position.

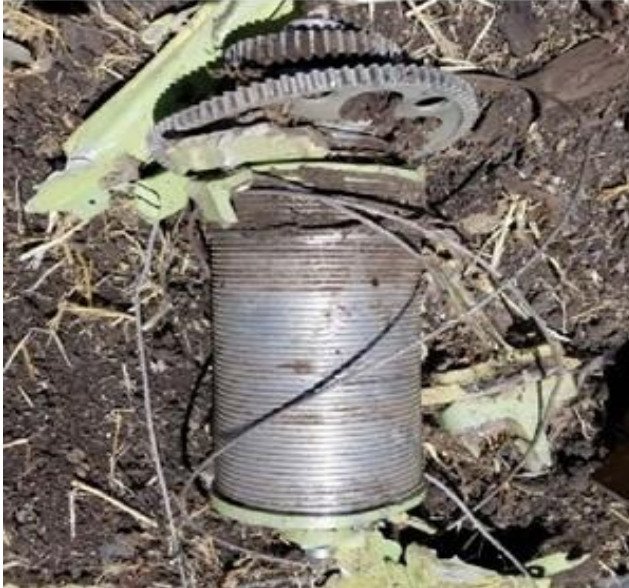
FIGURE 59: AFTCABLE DRUM

Two parts of the control system were located and examined at the impact site. One consists of aft cable drum; the other consists of the stab trim actuator (see Figures 59 & 60 below respectively). These

components do not provide any evidence of what position the horizontal stabilizer may have been at the time of impact.

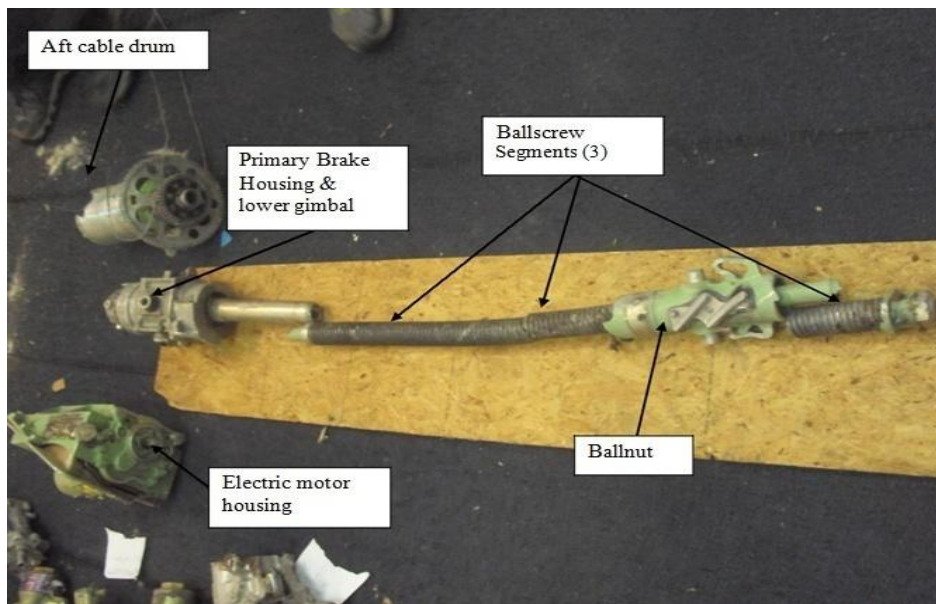
FIGURE 61: RECOVERED STABILIZER TRIM COMPONENTS

Most of the located components of the stabilizer trim system were located once the wreckage was transported to Bole International Airport. The only part of the stab trim system located on site was the motor housing (see above). Referencing **figure-54** above, the parts located in the wreckage pile at the airport consisted of the Primary Brake Housing (has the Lower Gimbal on it), the entire jackscrew (fractured into three pieces), and the ballnut (jammed onto the screw). Damage to the components of the stabilizer trim system is consistent with a high energy impact.

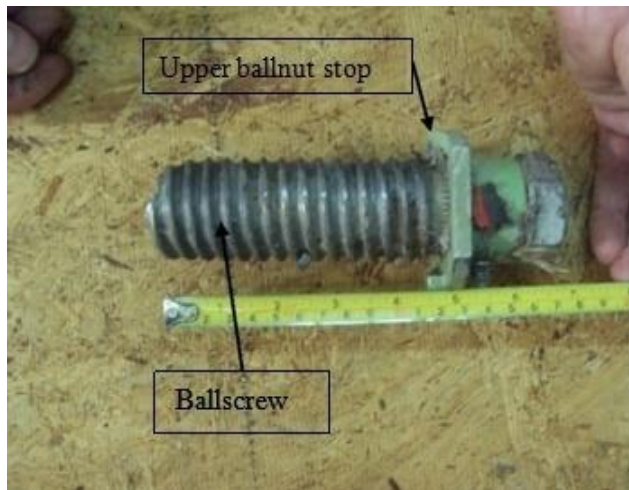
FIGURE 62: UPPER BALLSCREW SEGMENT

Examining the fracture surfaces, the upper screw segment fits with the fracture face just inside the ballnut giving a measurement between the stops on the ballnut and the upper ballnut stop of ~5". Referencing Boeing document D251A122 (737NG Control Position Data), this measurement equates to a stabilizer trim setting of 1.5 degrees Airplane Nose Down (AND) or an indicated position of 2.5 units of trim. Although the data is for the 737NG, the position of the MAX stab trim holds the same relationship. According to Boeing:

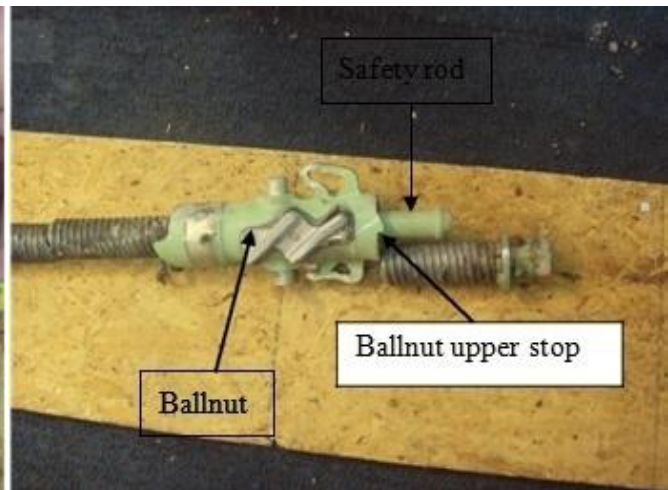
FIGURE 63: BALLNUT AND UPPER BALLSCREW SEGMENT

The figure below shows the relationship of the ballnut position along the ball screw. There is a safety rod which acts as a secondary load path should the ball screw fracture in service for any reason. It is attached to a separate set of secondary gimbals below the primary support gimbals on the primary brake housing and to the top of the ball screw. Figure 54 shows the safety rod and that it protrudes out from the ball nut. However, the fracture faces on the 5" long upper screw portion (*note the measurement in Figure 53*) match those found near the ballnut upper stop. This is consistent with the safety rod being pulled out several inches prior to final fracture.

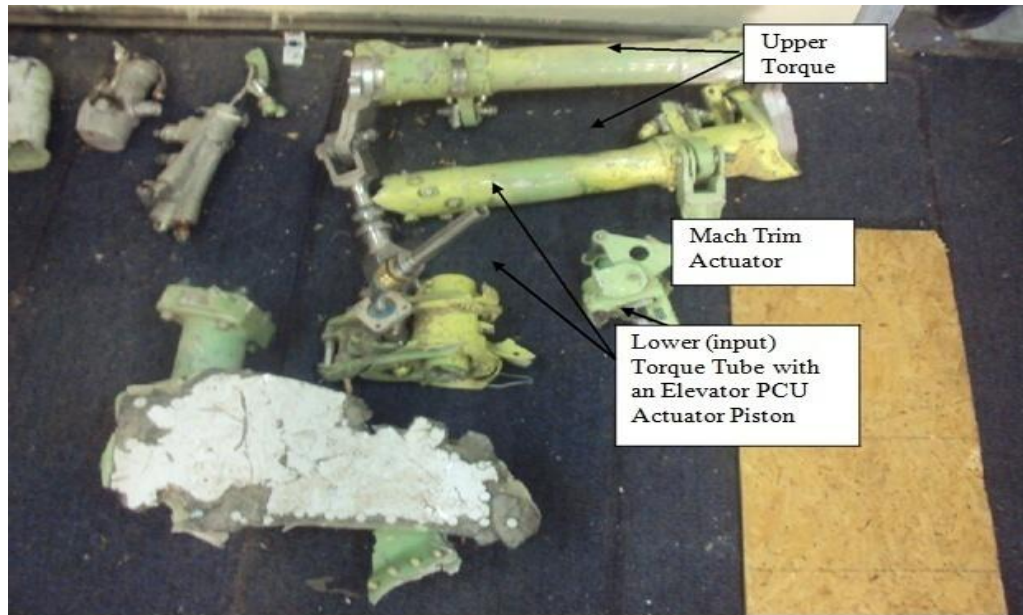
**FIGURE64: ELEVATOR PCU ACTUATOR PISTON**

The only components that were located for this system were the output torque tube, the mach trim actuator, a small portion of the Elevator feel and centering unit, and a small piece of the elevator input torque tube. Figure 55 above shows the recovered components of the elevator control system. Note that all components, like the lateral components show significant damage consistent with a high-energy impact. The upper torque tube was fractured in half. Only a small portion of the lower (input) torque tube was recovered along with a piston of the Elevator Power Control Unit actuator. The Mach Trim Actuator was found in the fully retracted position.

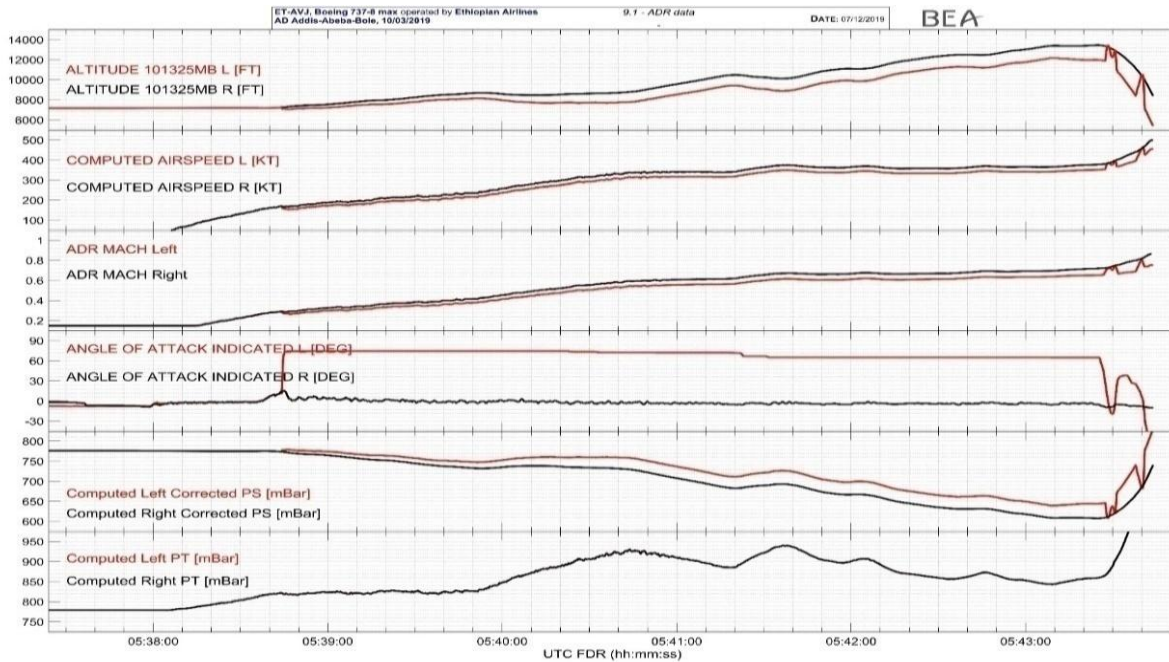
FIGURE 68: AIR DATA PARAMETERS

During the flight of the event, the left and right recorded altitude values, the recorded CAS values and the recorded Mach numbers diverged after LH and RH AOA values divergence.

Although not explicitly recorded, the RH and LH computed total pressure values calculated from the recorded parameters were found to match. The differences between the recorded Mach number and between the recorded computed airspeed values were consistent with a difference in the corrected static pressure values resulting from the left ADIRU's use of the erroneous left AOA sensor data.

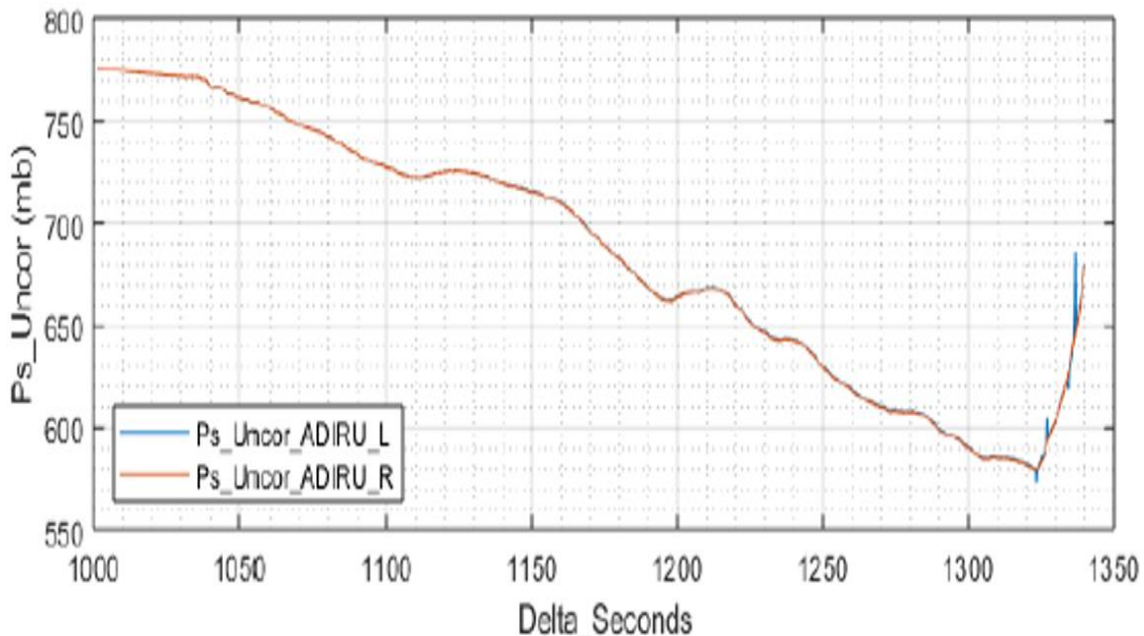
FIGURE 69: UNCORRECTED STATIC PRESSURE COMPUTED BY THE AIRPLANE MANUFACTURER

Uncorrected static pressure values from both sides were identical. The difference between the LH and RH side corrected pressure values were therefore only due to the AOA correction.

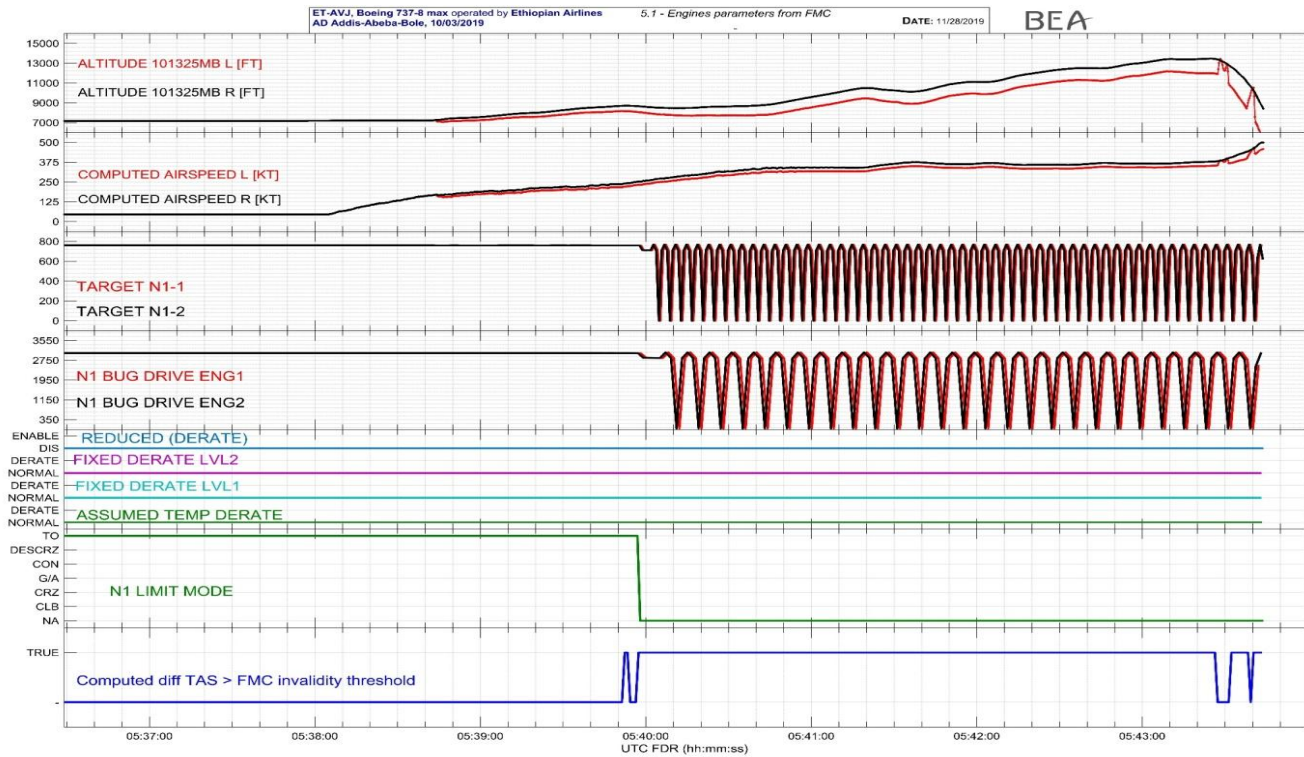
FIGURE71: FMC PARAMETERS FOR THE ENGINES

For the takeoff phase, the N1 limit mode was the TO mode and the N1 recorded values corresponded to 95% of N1_{MAX}. At 7,000 ft of elevation, it indicates that the take-off was performed with Max. Takeoff Thrust. Indeed, at 7,000 ft of elevation, between 15°C and 20°C, the Max. Takeoff thrust corresponds to 95% of N1.

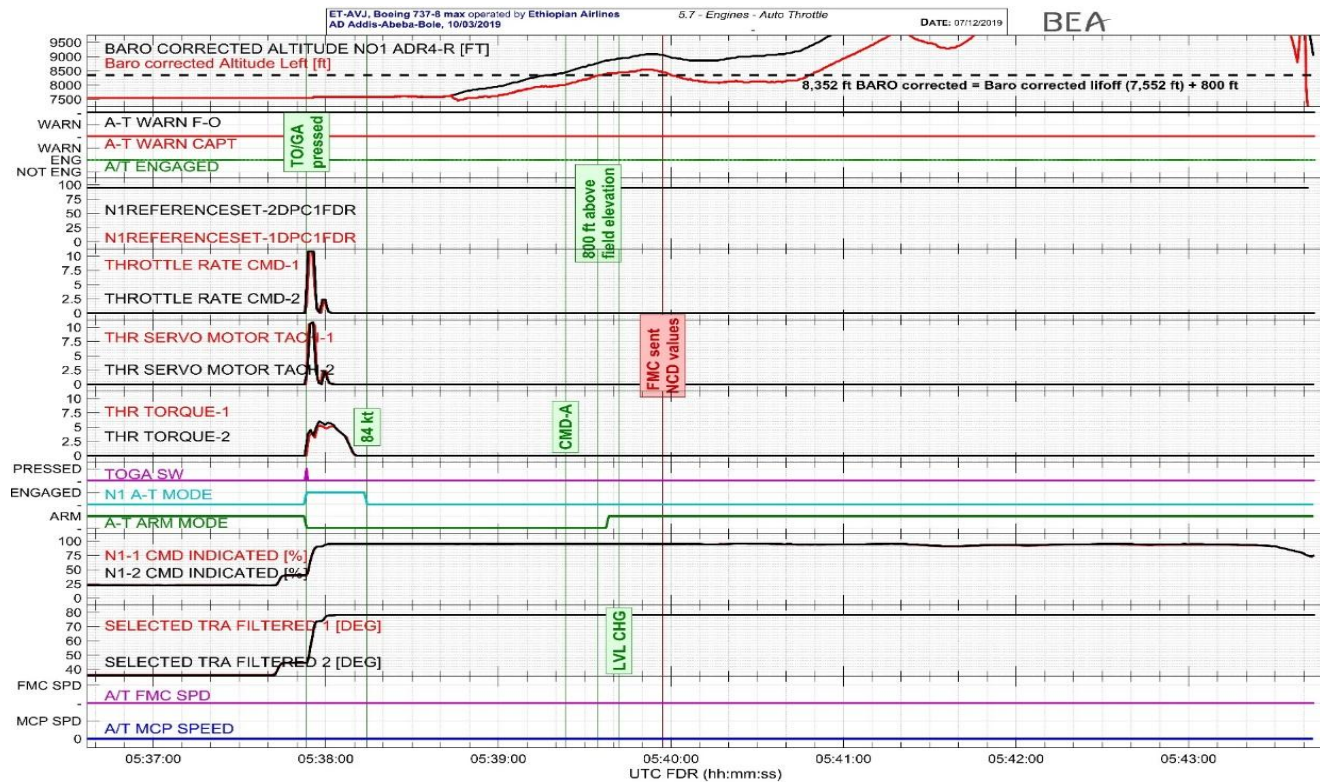
FIGURE 73: AUTO THROTTLE BEHAVIOR DURING THE FLIGHT OF THE EVENT

At 05 h 37 min 53 s, the TO/GA switch was pushed. A/T switched to the N1 mode. The A/T moved automatically the throttles forward (*THROTTLE RATE CMD*-[1/2] values, *THR TORQUE*-[1/2] values were positive). Once the throttles reached takeoff thrust, they remained there. As noted earlier, the normal

automatic reduction to climb thrust did not occur because the LH and RH TAS diverged by more than 25Kt before the FMC sensed that the Airplane had reached the thrust reduction altitude.

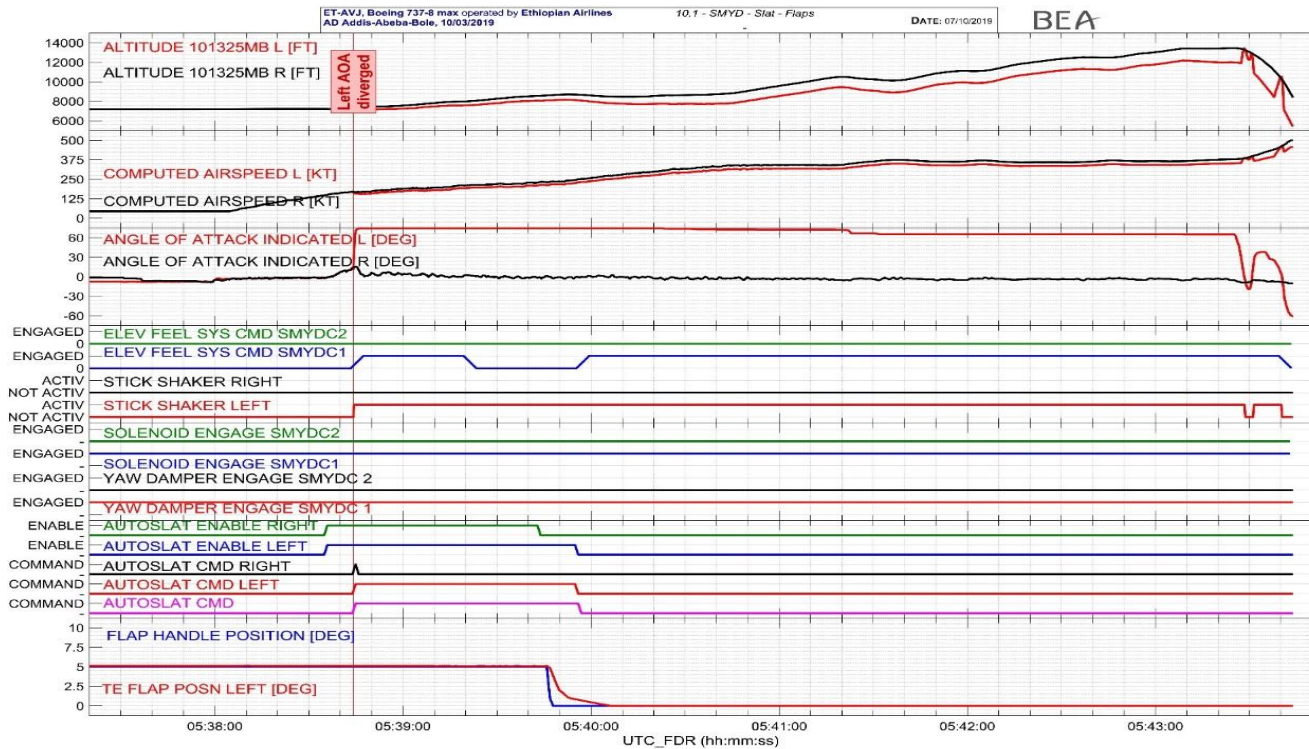
FIGURE74: AUTOSLAT, LEFT STICK SHAKER AND ELEVATOR FEEL SYSTEM

- the autoslat system triggered (SMYDC 1),
- the LH stick shaker engaged
- the LH elevator feel shift triggered.

At 5 h 39 min 56 s, the autoslat command ceased, the flap handle was at 0 position and flaps were moving up (flaps position lower than 1) with LH computed airspeed values reaching 230Kt and RH computed airspeed value 250Kt.

At 5h 39 min 44s SMYDC-2 disabled the RH autoslat function due to the RH computed airspeed (230Kt reached). SMYDC1 disabled the LH autoslat function 12s later due to the invalid LH computed airspeed.

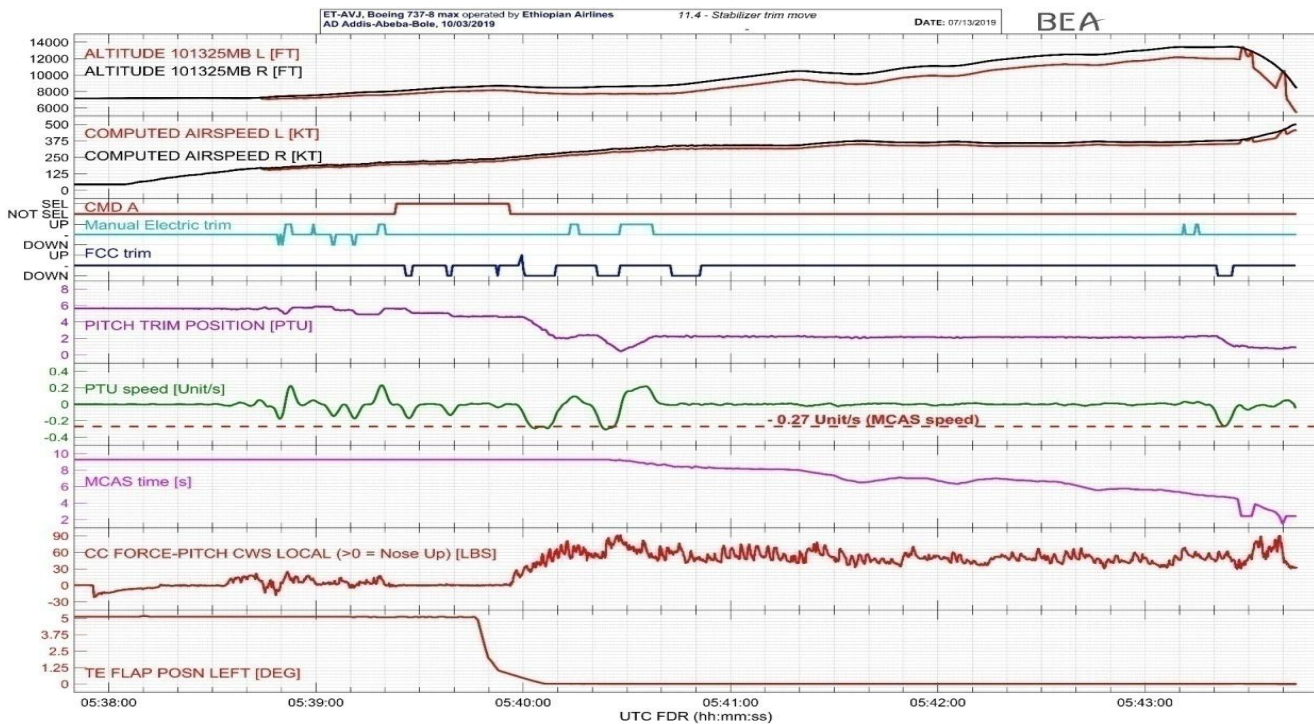
FIGURE 76: STABILIZER COMMANDED MOVES

During the beginning of the flight, several manual electrical trim inputs were recorded. These inputs reduced the force the captain needed to apply to the control column to maintain the desired path (this is the

normal and intended function of stabilizer trim in manual flight). Between the liftoff and the engagement of CMD A, the stabilizer moved between 4.9 and 5.9 units. When A/P was engaged, the stabilizer was at 5.6 units.

Under A/P, 3 FCC A/P trims down commands were recorded and the stabilizer trim values decreased to 4.6 units. When A/P disengaged, one single sample of FCC trim UP was recorded (Speed Trim activation).

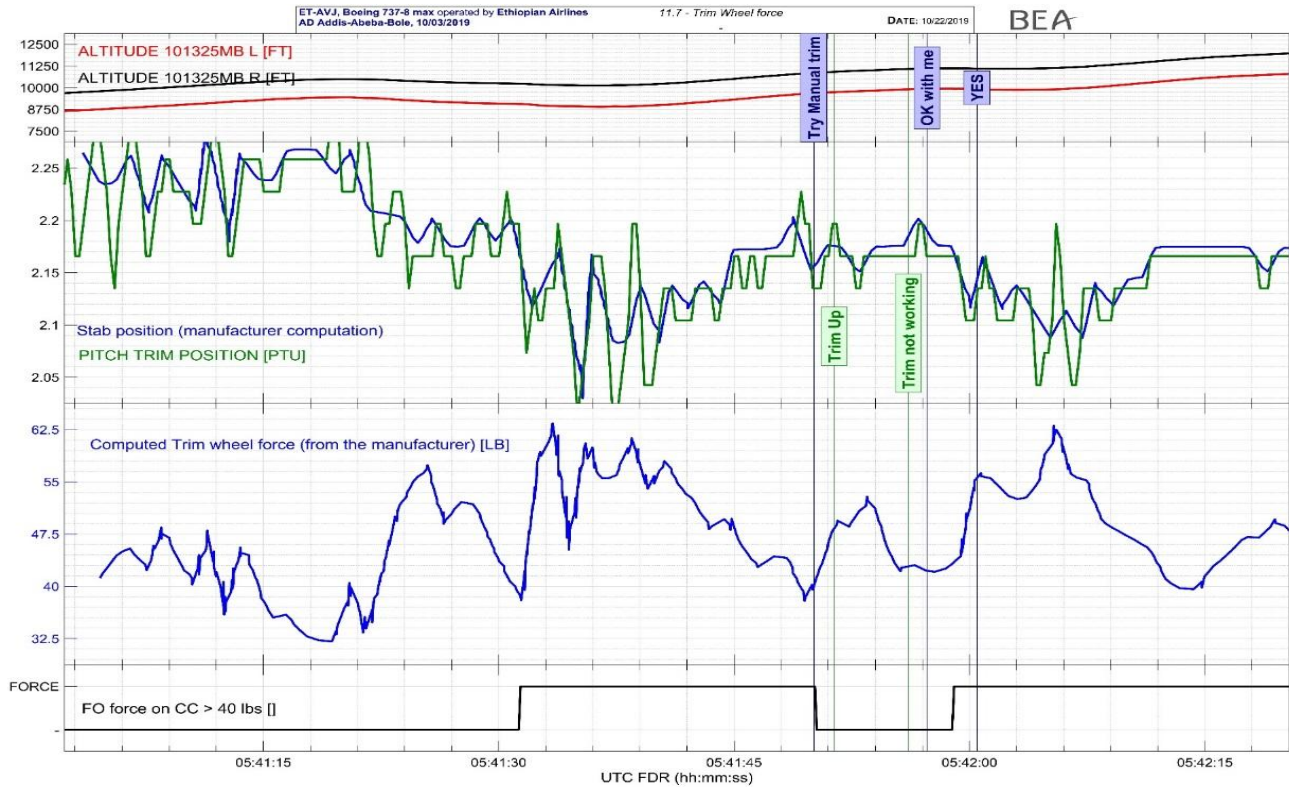
FIGURE 77: FORCE NEEDED TO MOVE THE TRIM WHEEL

- At 5 h 41 min 50 s, the captain requested the F/O to try moving the trim manually.
- At 5 h 41 min 50.5 s: a sound similar to the trim wheel handle extension was detected.
- At 5 h 41 min 51 s, the first officer confirmed “Trim up”
- At 5 h 41 min 55.5 s, the captain used an “expression of expectation”
- At 5 h 41 min 56 s, the first officer stated: “it is not working”.

The time during which the F/O tried to manually move the trim was then between 5 h 41 min 51 s and 5 h 41 min 56 s.

By the time the FO tried to move the trim wheel manually a force between 42 lbs and 53 lbs was required according to the Airplane manufacturer computation, (see Figure 77).

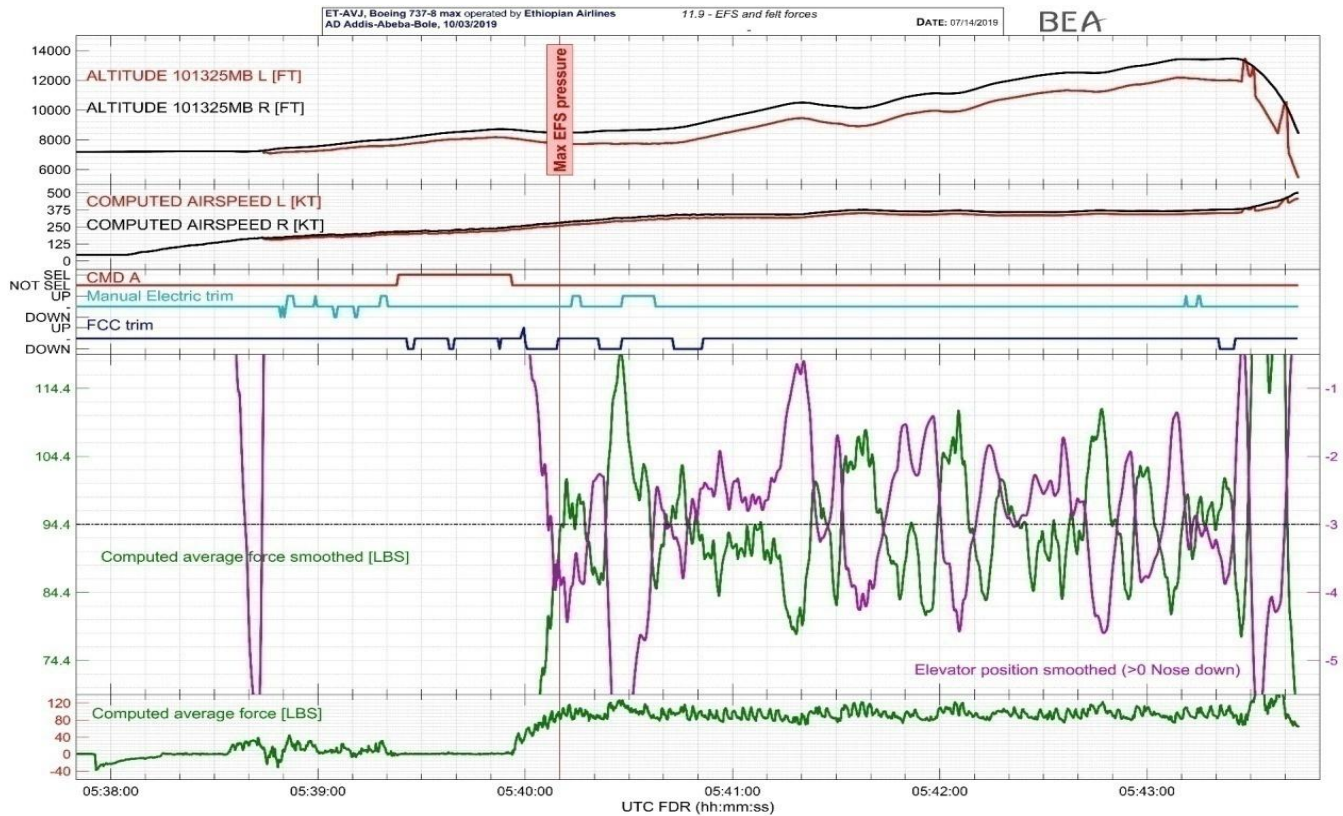
FIGURE 79: FELT FORCE AND ELEVATOR POSITION

Before the A/P engagement, the recorded low force level underlined an Airplane rather properly trimmed in pitch. At that time, the stabilizer position was 5.62 units (nose up setting) and the elevators position was of 3.5° (nose down setting).

The gradient of force felt by the crew can be illustrated by the comparison between the force applied on the control column and the position of the elevator. Note that because the flight conditions resulted in the Maximum feel pressure, the activation of EFS had no effect on these forces.

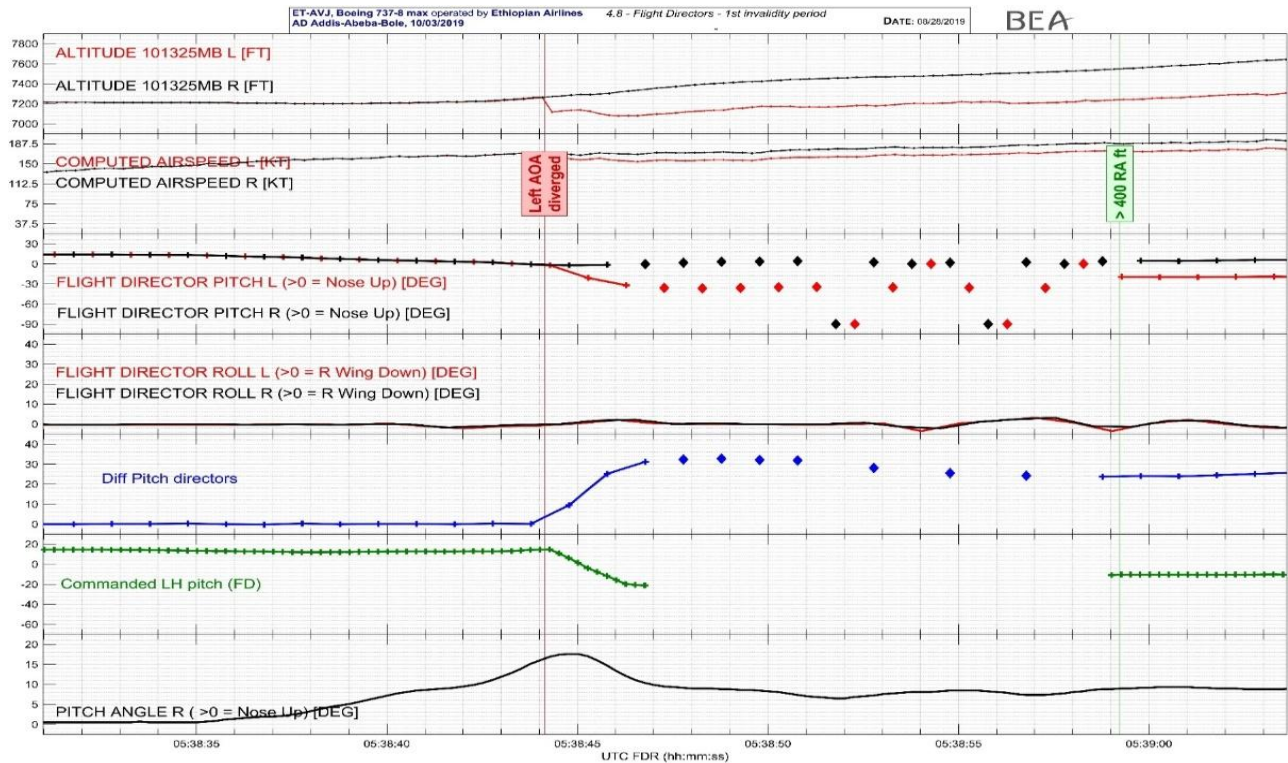
FIGURE 81: FLIGHT DIRECTORS - START OF THE FLIGHT

At the time of the 1st invalidity, F/D was in T/O mode and the radio altitude was lower than 400 ft.

Note: Below 400 ft, during TO mode, LH and RH pitch bars positions are compared with each other. If the difference between both pitches bars position exceeds a defined threshold, both pitch bars are BOV.

When the LH and RH AOA values diverged, LH pitch F/D commands recorded values quickly decreased to -32° while RH pitch F/D recorded values slightly increased to -0.4° . The difference between LH pitch F/D values and RH pitch F/D values were greater than the threshold above which FCCs comparators triggers and both F/D pitch were biased out of view.
